Manhole Inspection Summary

Manhole # **S39GG_035MH**

Insp Date: **1/15/08 9:21 AM**

Location Address: **1110 HOFFMAN ST**

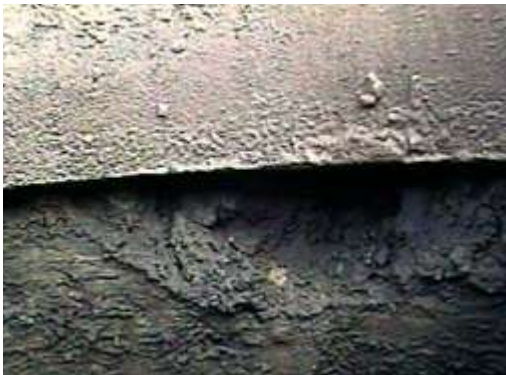
Defect 1

Condition: ☐ Sound ☐ Cracked ☐ Root Intrusion ☒ **Loose Brick** ☐ Deteriorated

LOOSE BRICKS

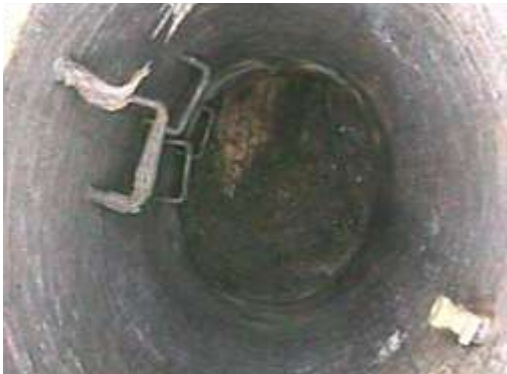
Defect 3

Steps Count: **6** Missing: **1** ☒ **Corroded**

STEPS CORRODED

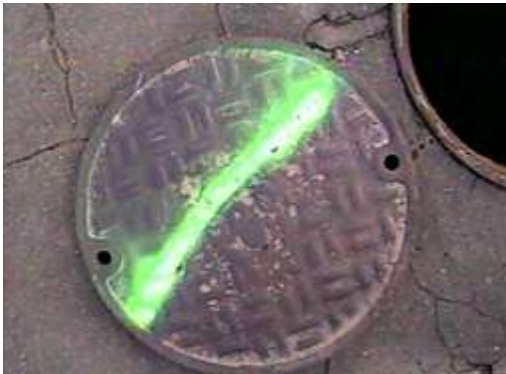
Defect 2

Type: **Sanitary** Condition: **Cracked** Cover Material: **Cast Iron**

CRACKED COVER

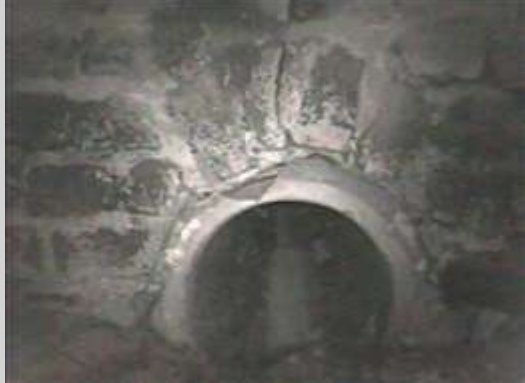
12 O'Clock Outflow

8 in. Circular Gravity Sewer
Pipe Out @ 12 O'Clock

Pipe Material: **Clay** ☐ Pipe Lined

Invert Depth: **10.50** (ft.) Flow Characteristics: **None**

Deposits: ☒ None ☐ Mud ☐ Sludge ☐ Debris ☐ Grease

Infiltration: **None** Pipe Seal Cond: **Sound**
